EAST LAKE RESERVOIR DAM

CT. 00066

PHASE I INSPECTION REPORT
NATIONAL DAM INSPECTION PROGRAM

JANUARY 1979

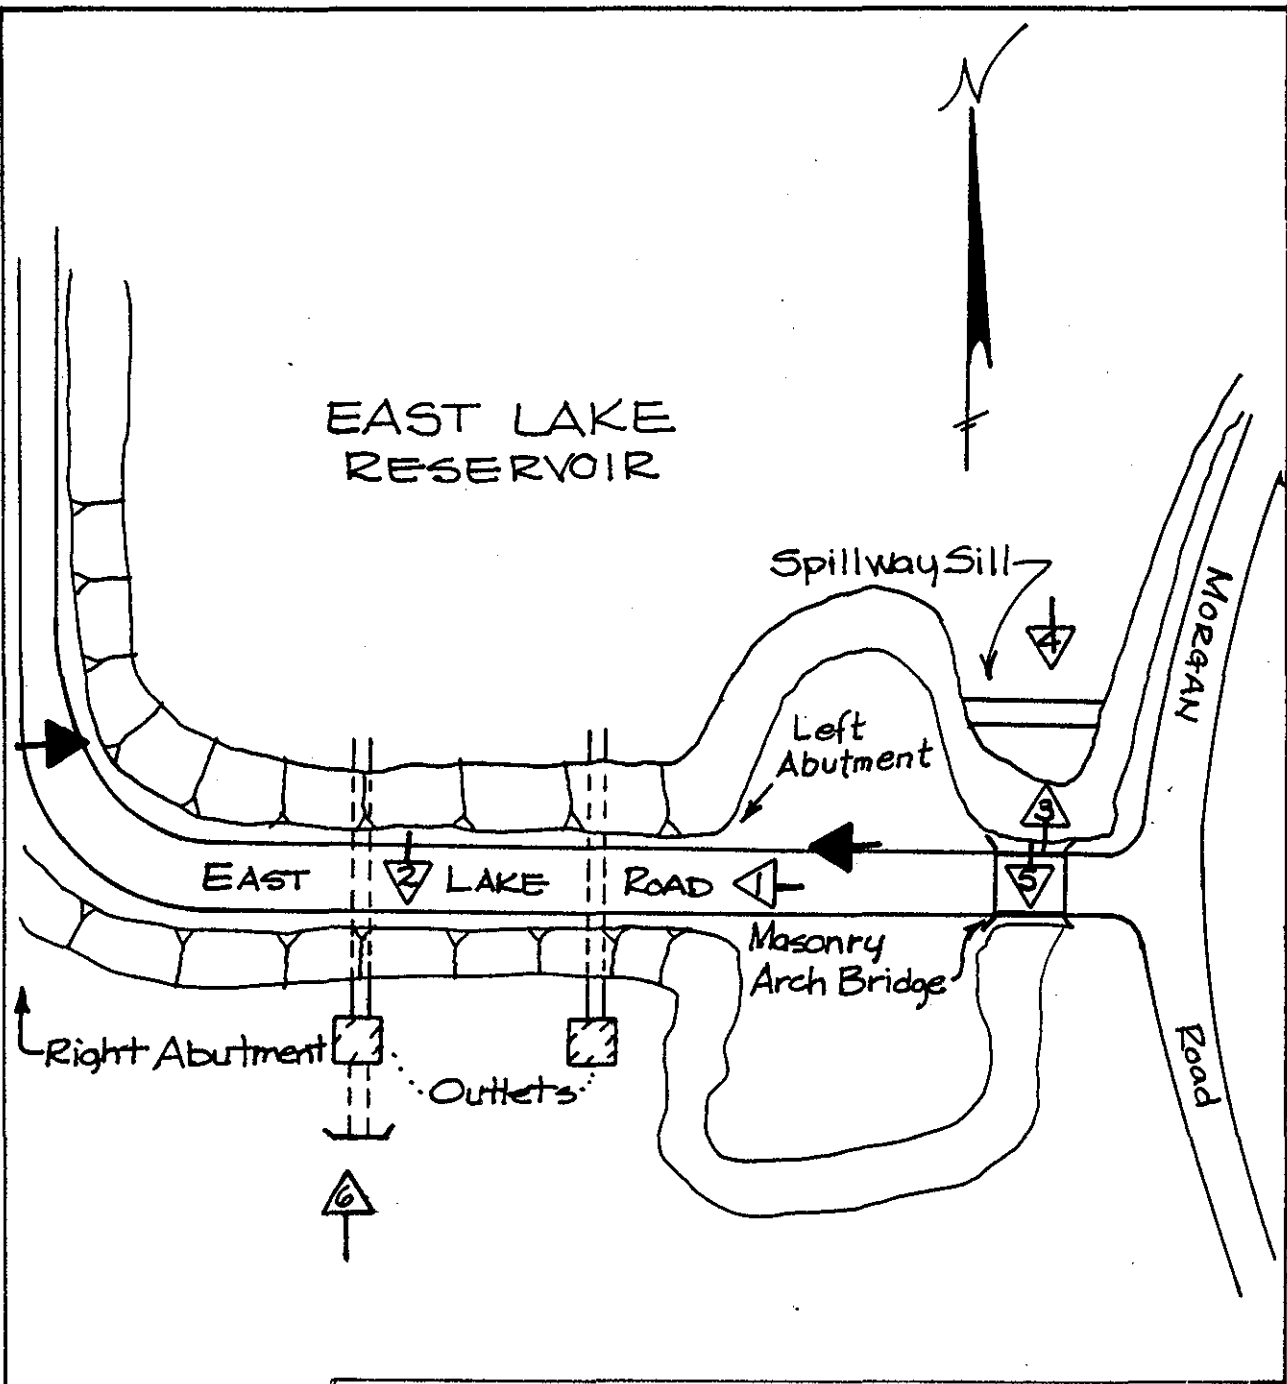
The downstream slope of the dam is also very steep at the top and it would seem that the highway has been raised and widened without a corresponding fattening of this slope. Within the west third of the dam, for example, longitudinal cracks are evident in the surface of the road indicative of sloughing. There is also as much as 2-3 ft. differential between gutter and crown on the downstream side. The tilting of the guard rail posts associated with slope sliding is illustrated in Photo No. 1 (Appendix C).

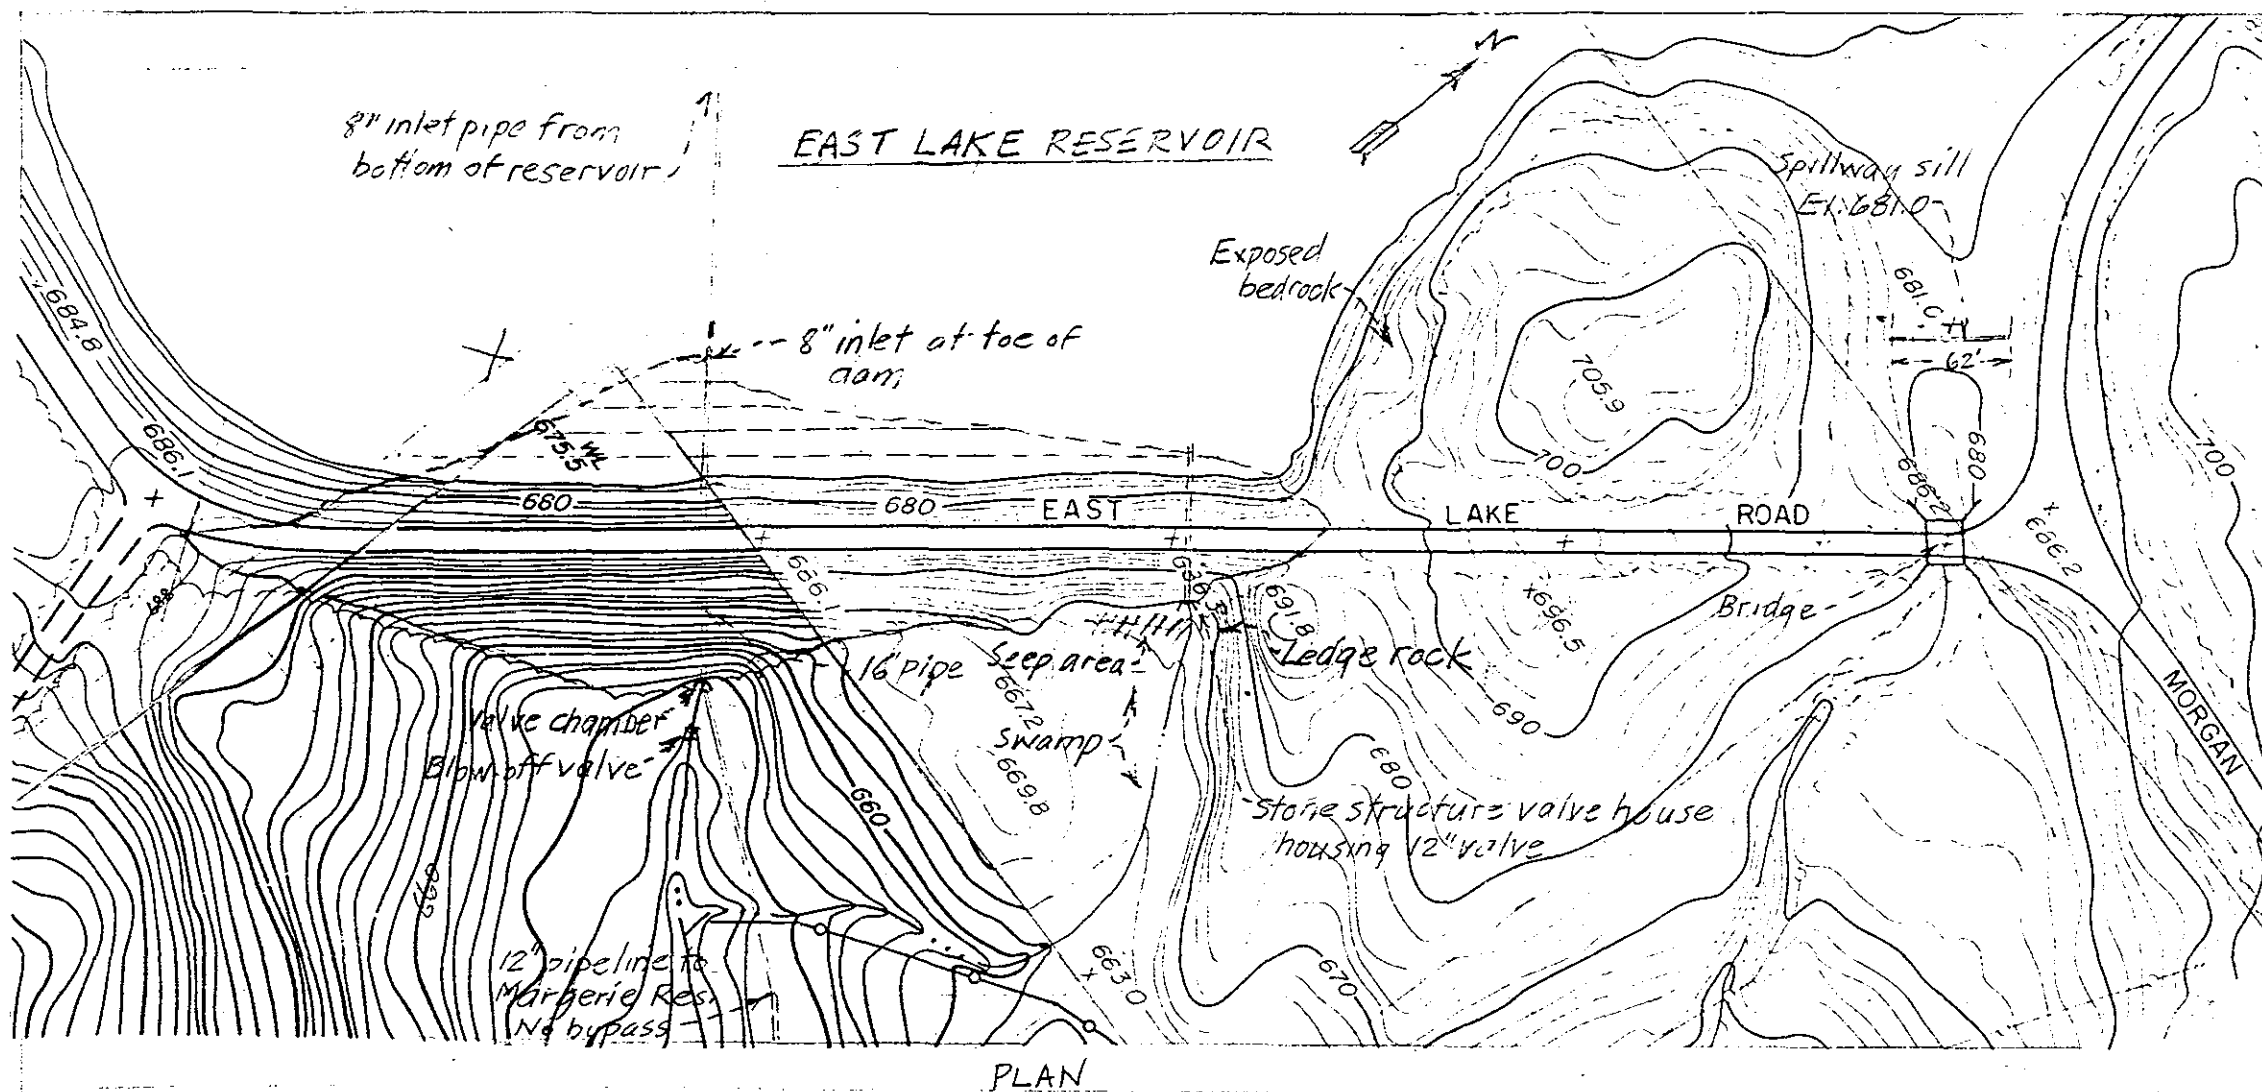
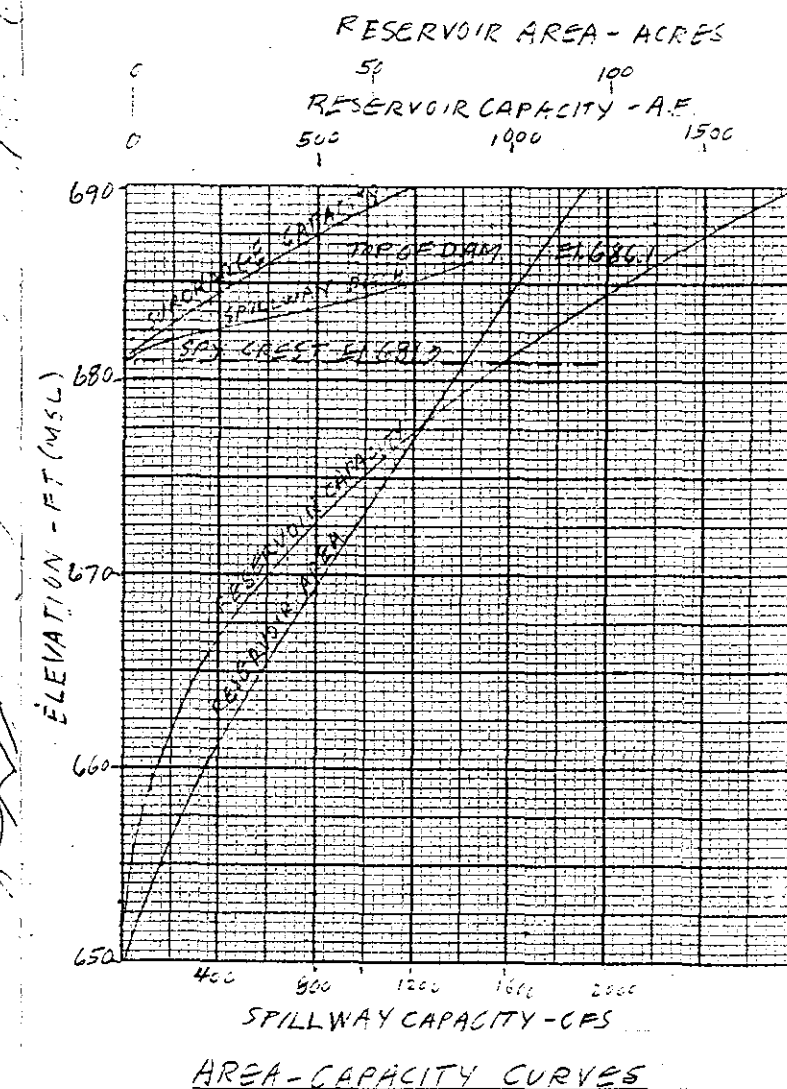
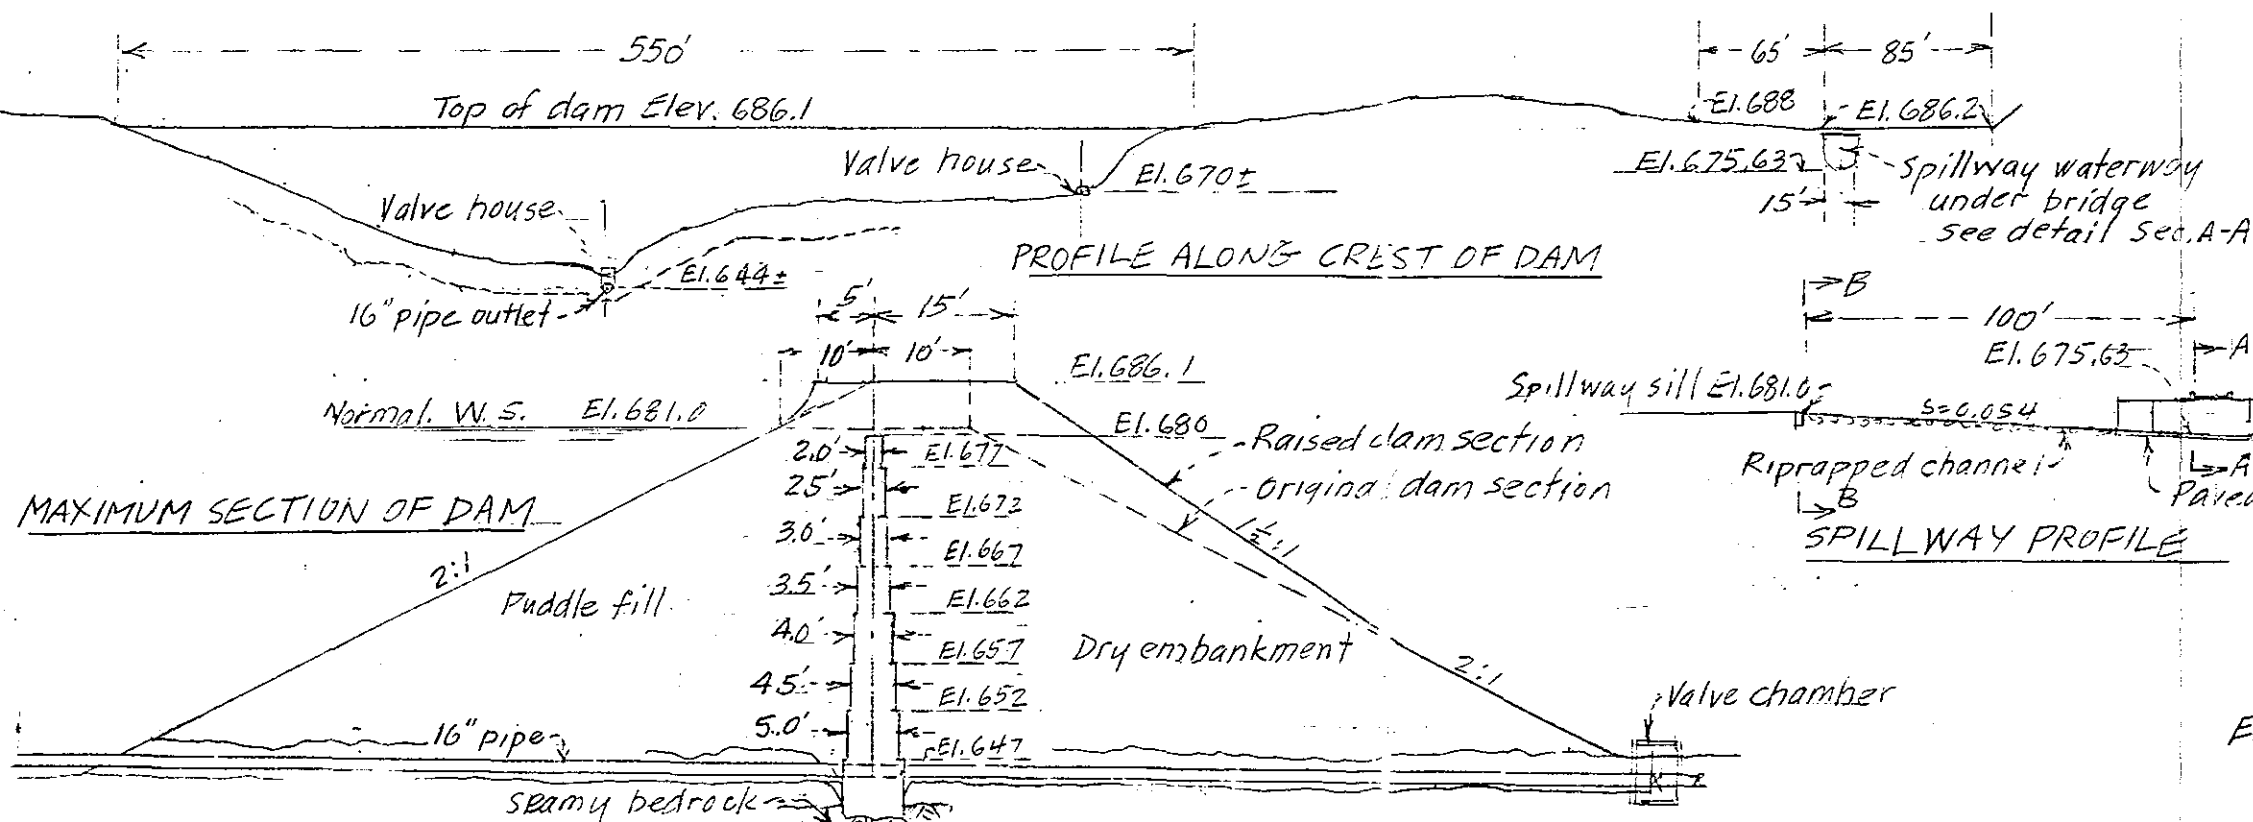
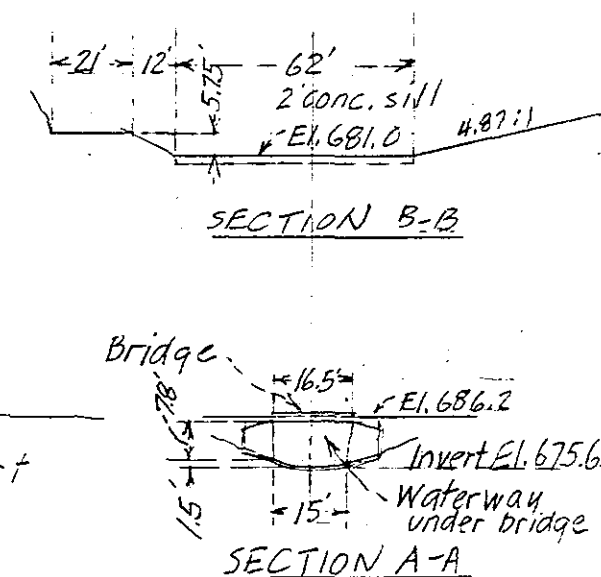
FIGURE 1 Sheet D-1

The central core wall now extends to within 6 ft. of the crest of the dam. The wall increases in thickness in steps, starting with a 2 ft. thickness at the top and varying 6 in. every 5 ft. as it extends downward. The base of the wall was placed in a core trench which was excavated for the most part to "ledge" or "seamy rock". Grouting of the bedrock has not been documented and it is not believed that any form of foundation treatment was carried out. The left abutment is founded on a rock outcrop promontory which separates the dam from the spillway. Sketch plans and profiles of the dam and appurtenant structures are delineated on Fig. 1, Sheet 1, Appendix D.

The crest of the dam accommodates a local road which crosses the spillway channel via a bridge constructed about 100 ft. downstream from the control sill. This bridge appears to be of more recent construction and probably replaces an older bridge. The present bridge is of shorter span than that shown on an old sketch for the original design and considerably restricts the waterway area for carrying larger spillway discharges. The span of the bridge is about 15 ft. The invert of the waterway under the bridge is paved with a concrete lining. Converging approach walls are provided to the waterway under the bridge. Details of the spillway and bridge are delineated on Figure 1, Sheet D-1, Appendix D.

Except for several rough sketches of the dam cross section and profile, no layout drawing or design data have been recovered. In 1967 the City of Danbury had topographic mapping prepared, including the East Lake Reservoir area, by photogrammetric methods, at 100 ft. to the in., which delineates the location and elevations of the dam and spillway. In the course of the inspection, measurements were also taken of the structures and a plan and profile layout was prepared. This sketch plan is shown on Figure 1, Sheet D-1, Appendix D.
